Service Log AN/GRC-109 communication system  
PP2684/GRC109 rebuild  
26-Dec-2019, Virgil Cheng vr2xgm

Power section service history:

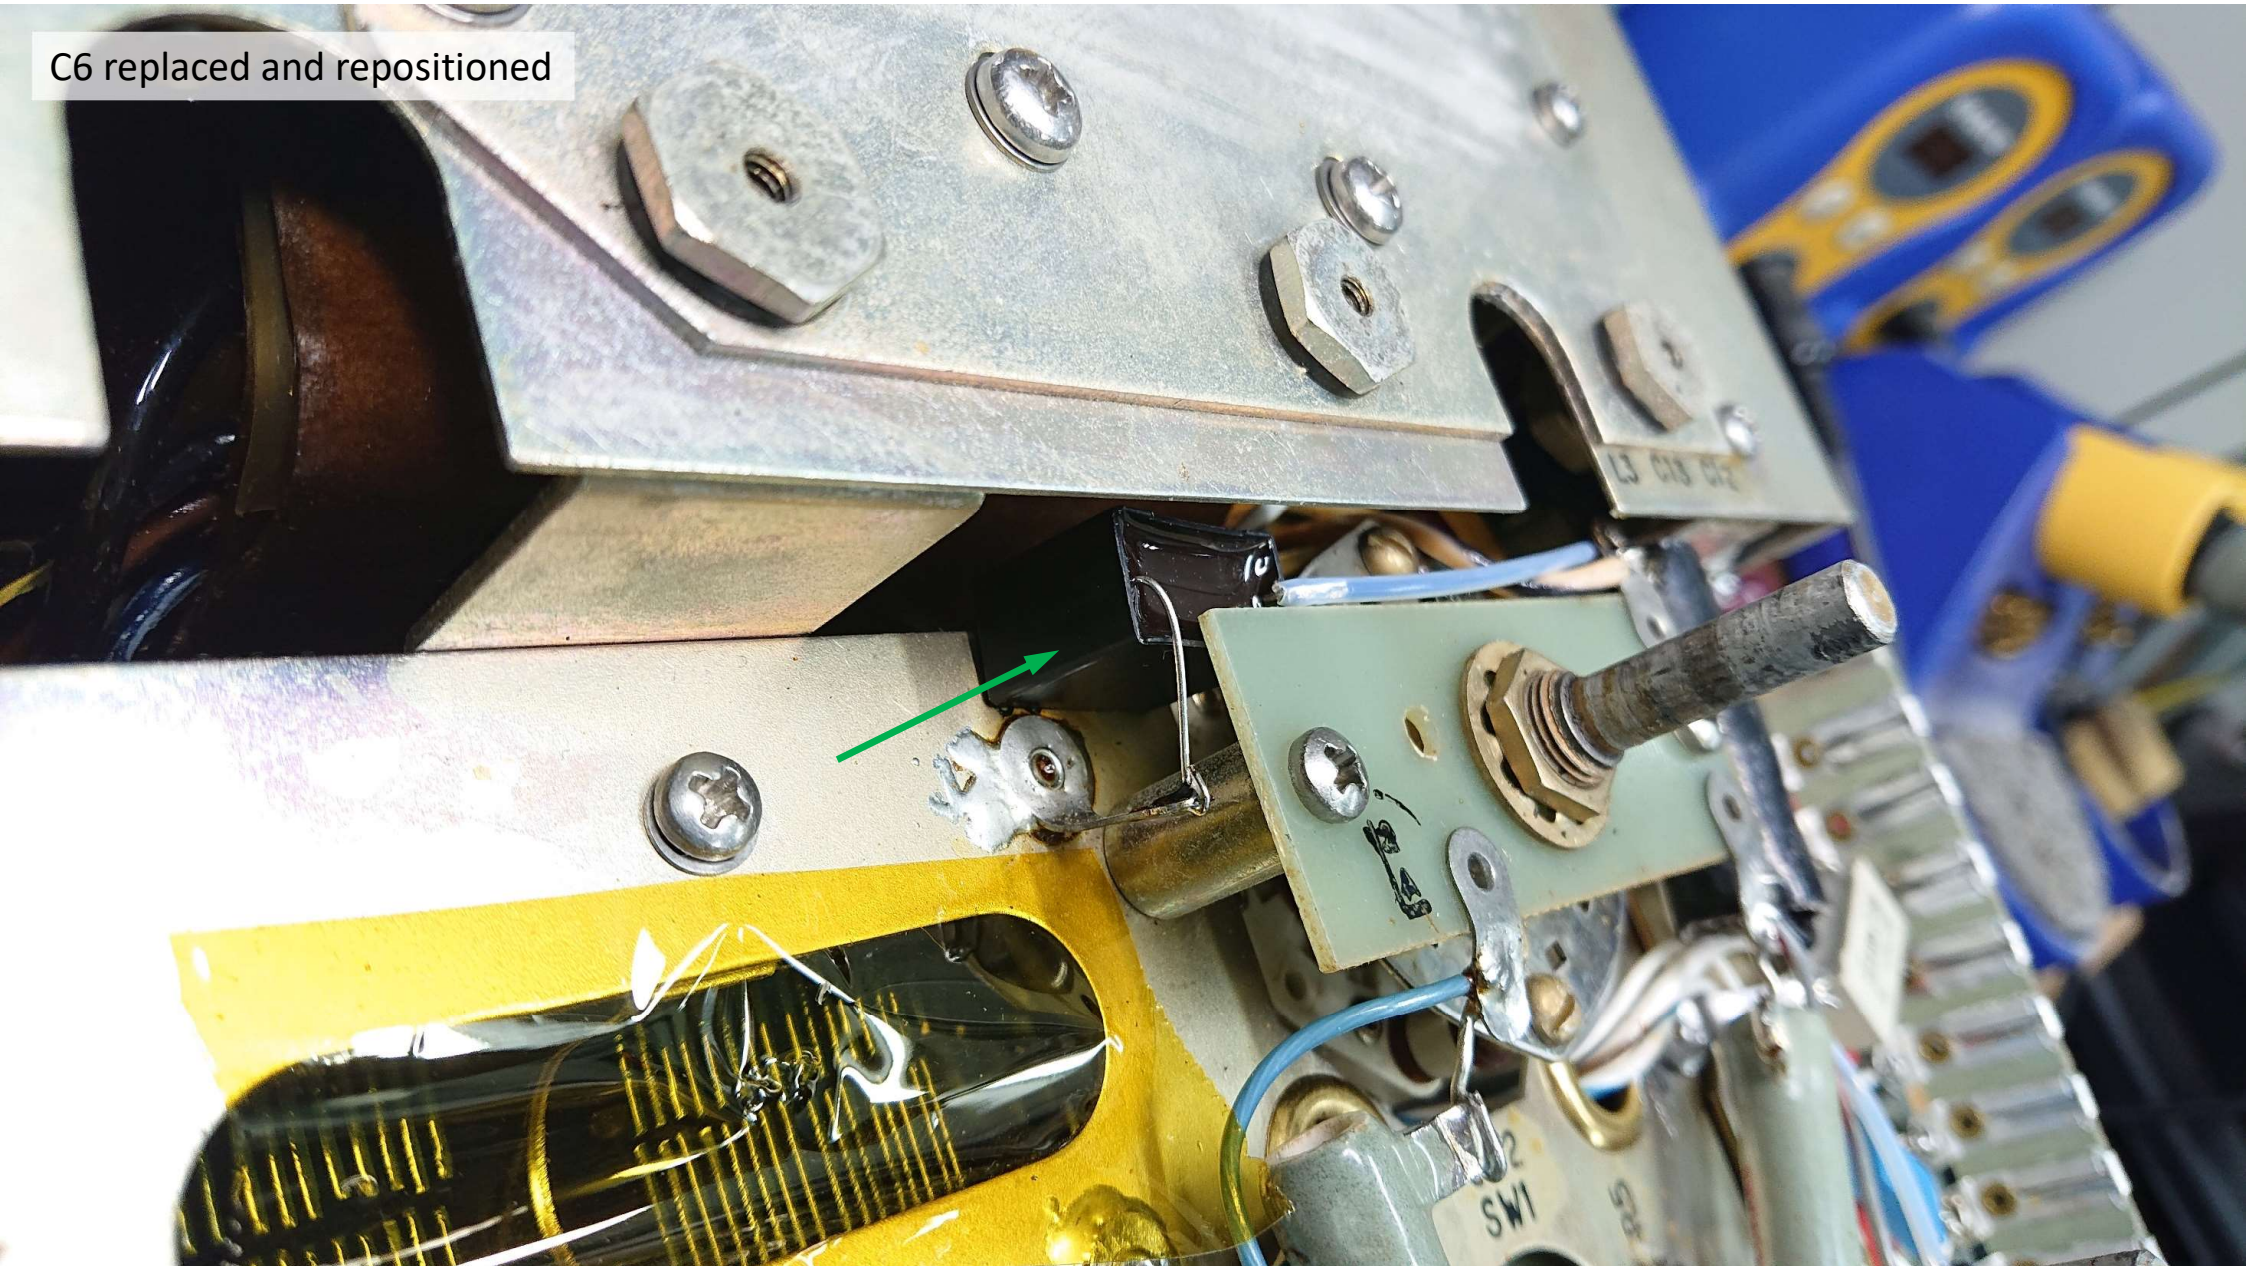
C10,11,12,13 replaced

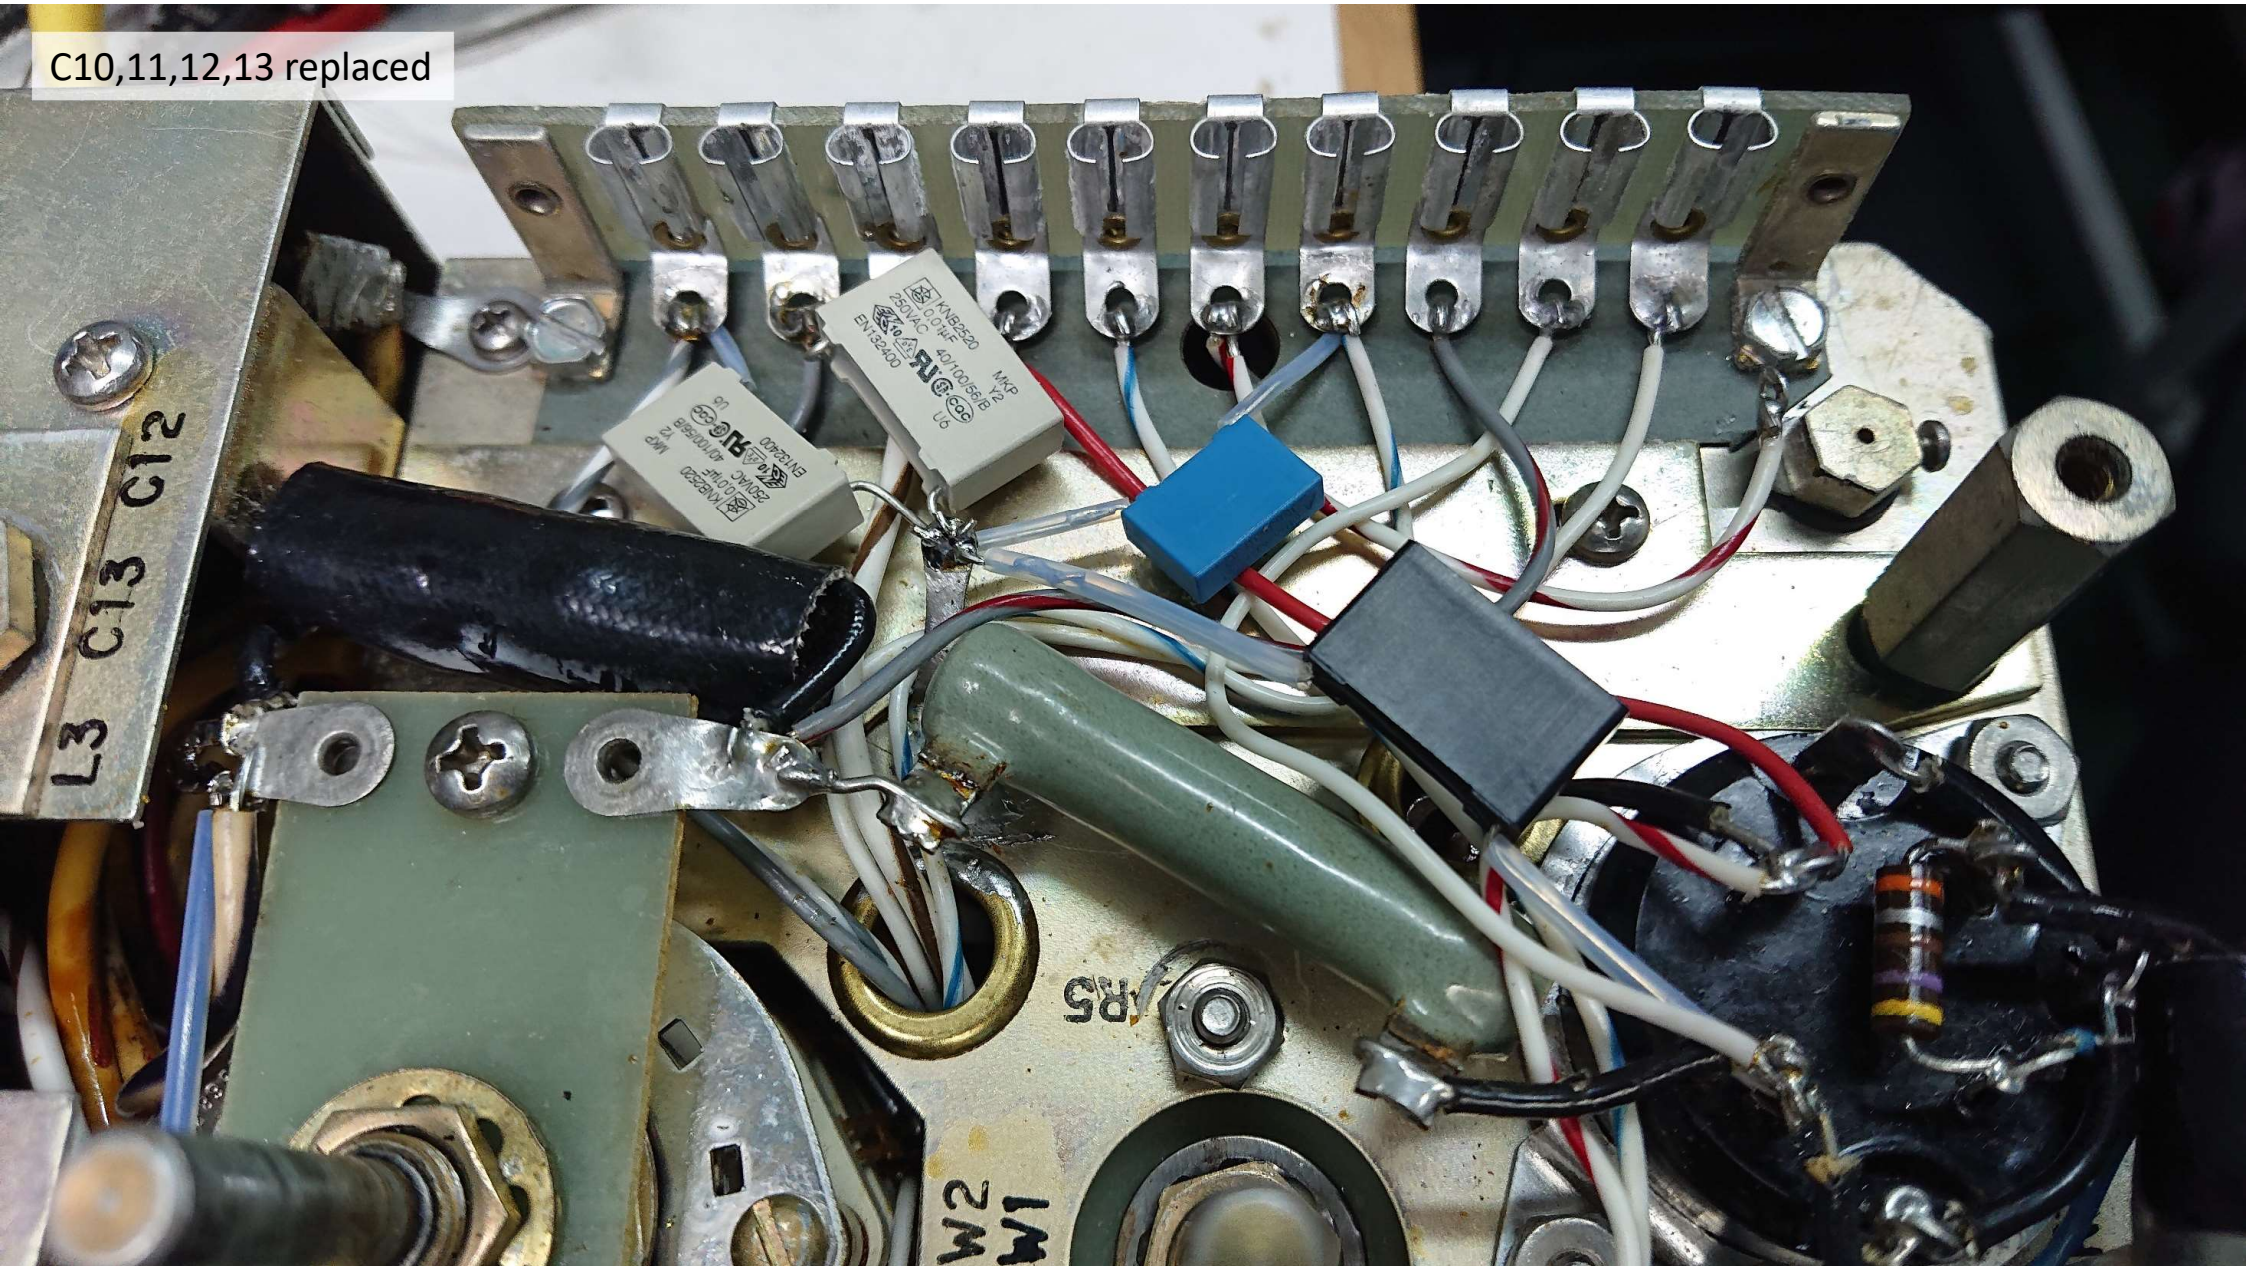
Refilling C4/C5/C7

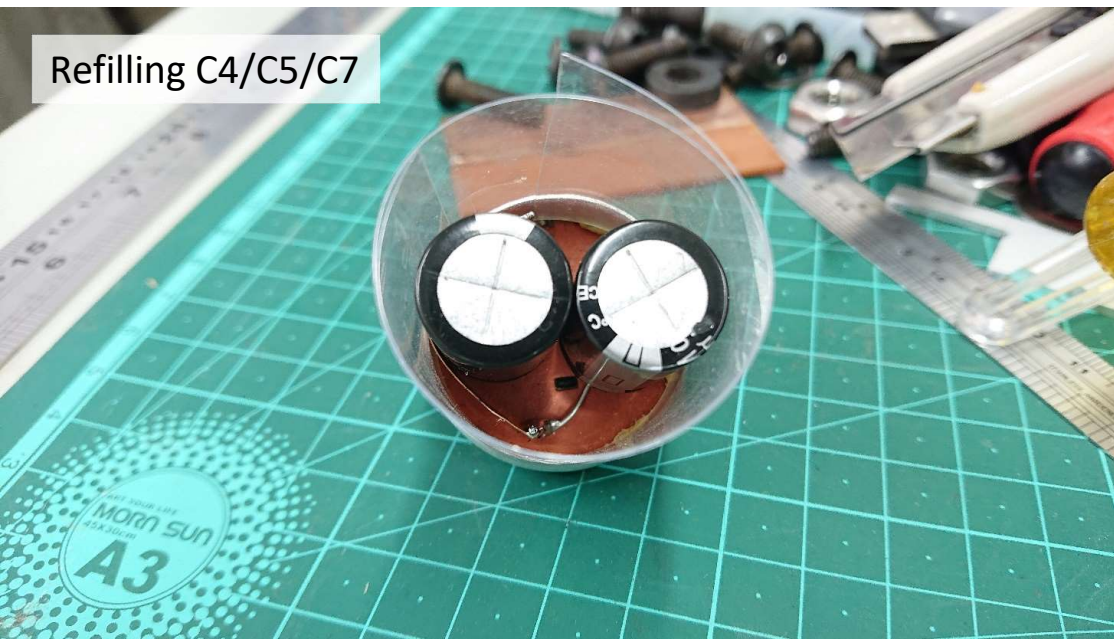
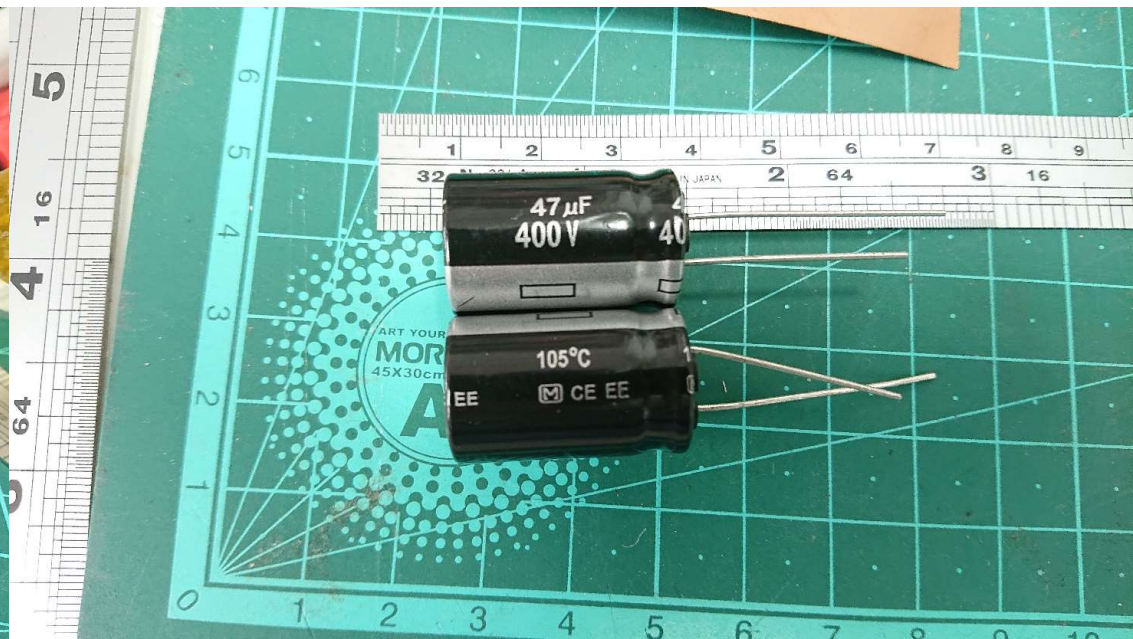
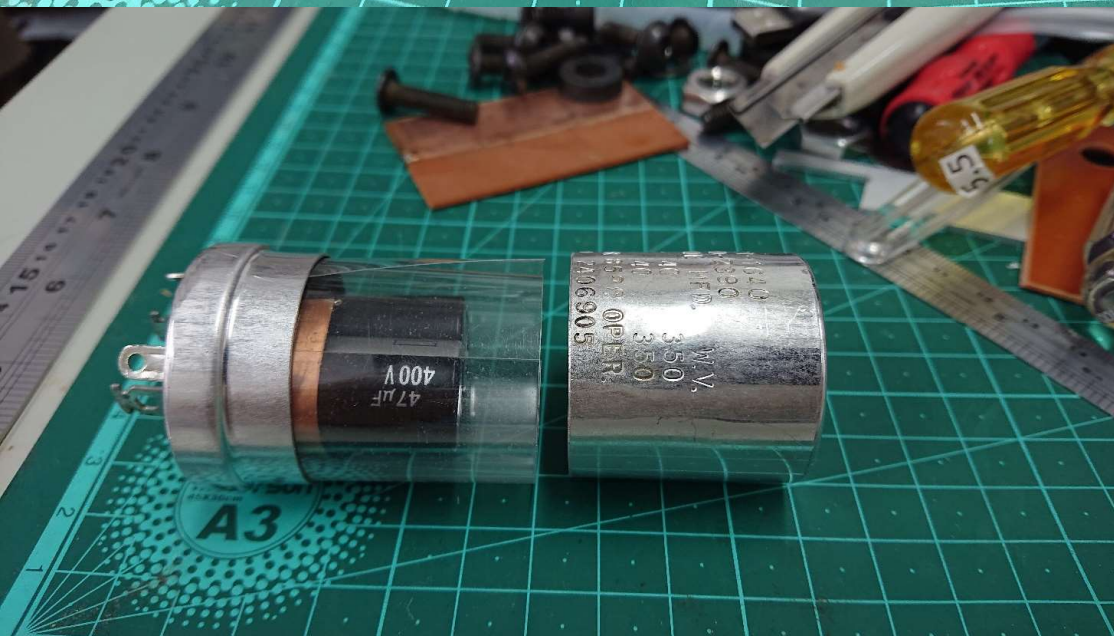
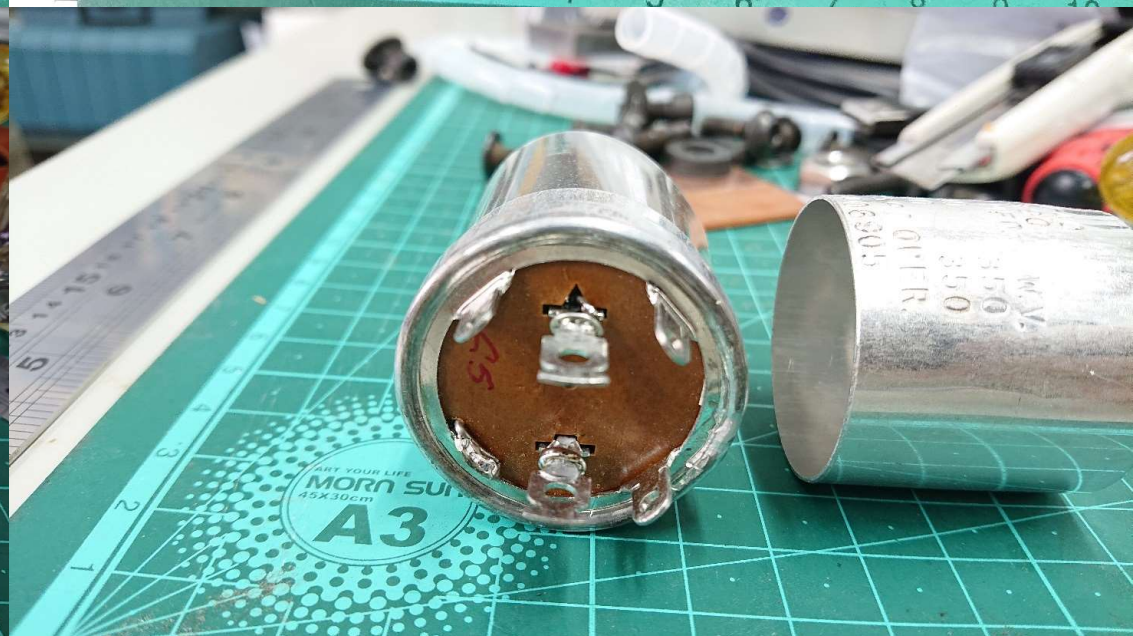
C4/C5/C7 refilled, re-sealed

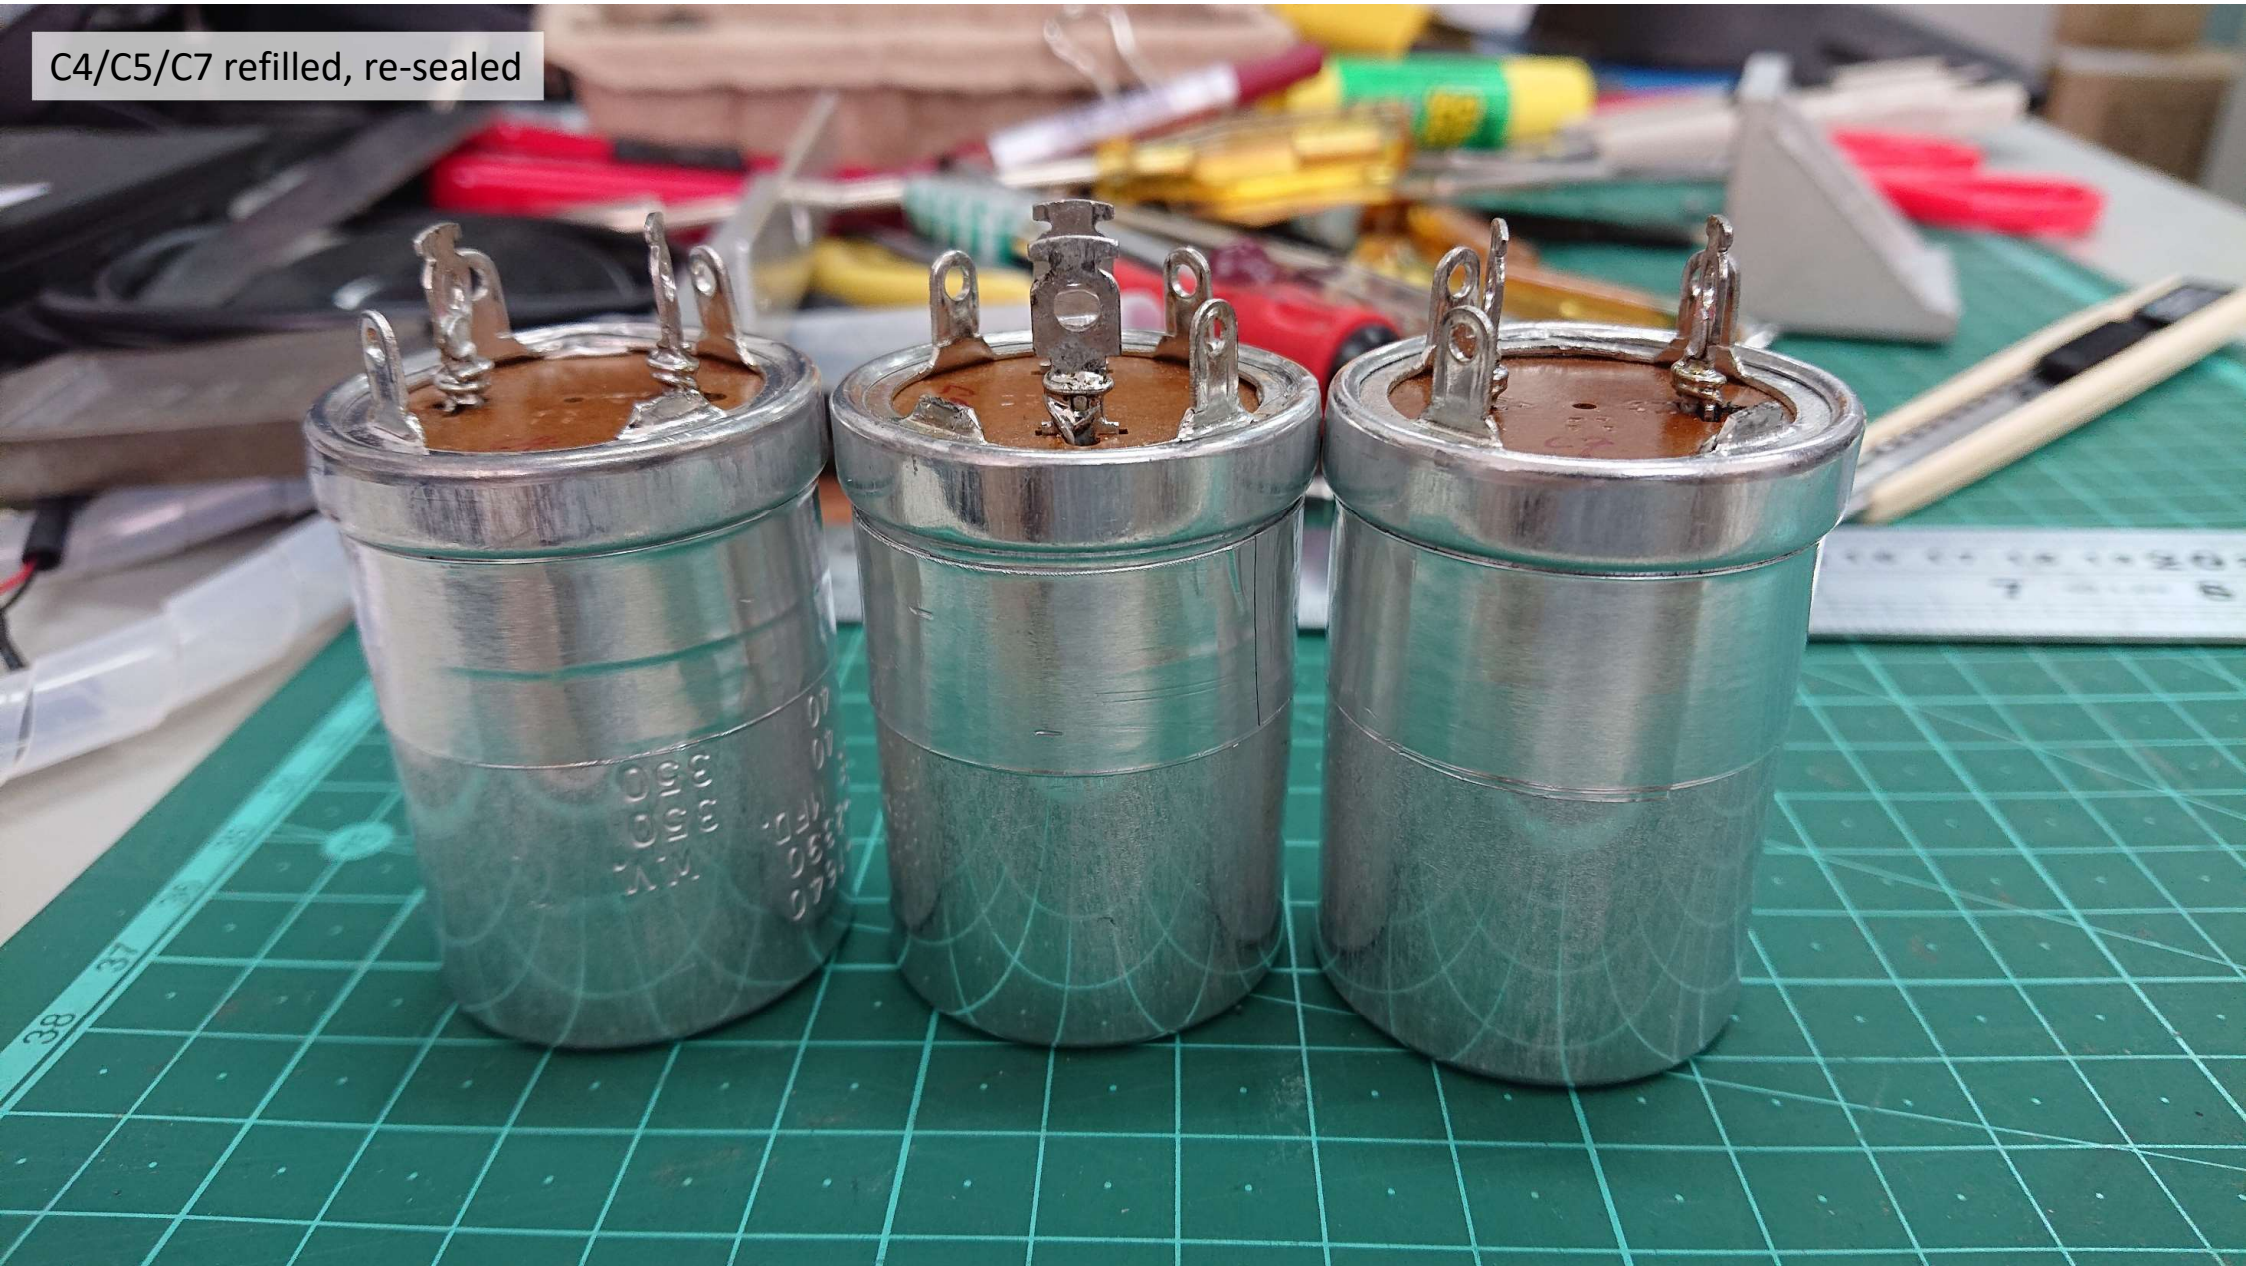
C4/C5/C7 installation C4 housing has high voltage DC potential, must be insulated  
C5,C7 housing too close to wafer switch, also need insulation  
New C8,C9 can be seen at two corners, size much smaller than old component

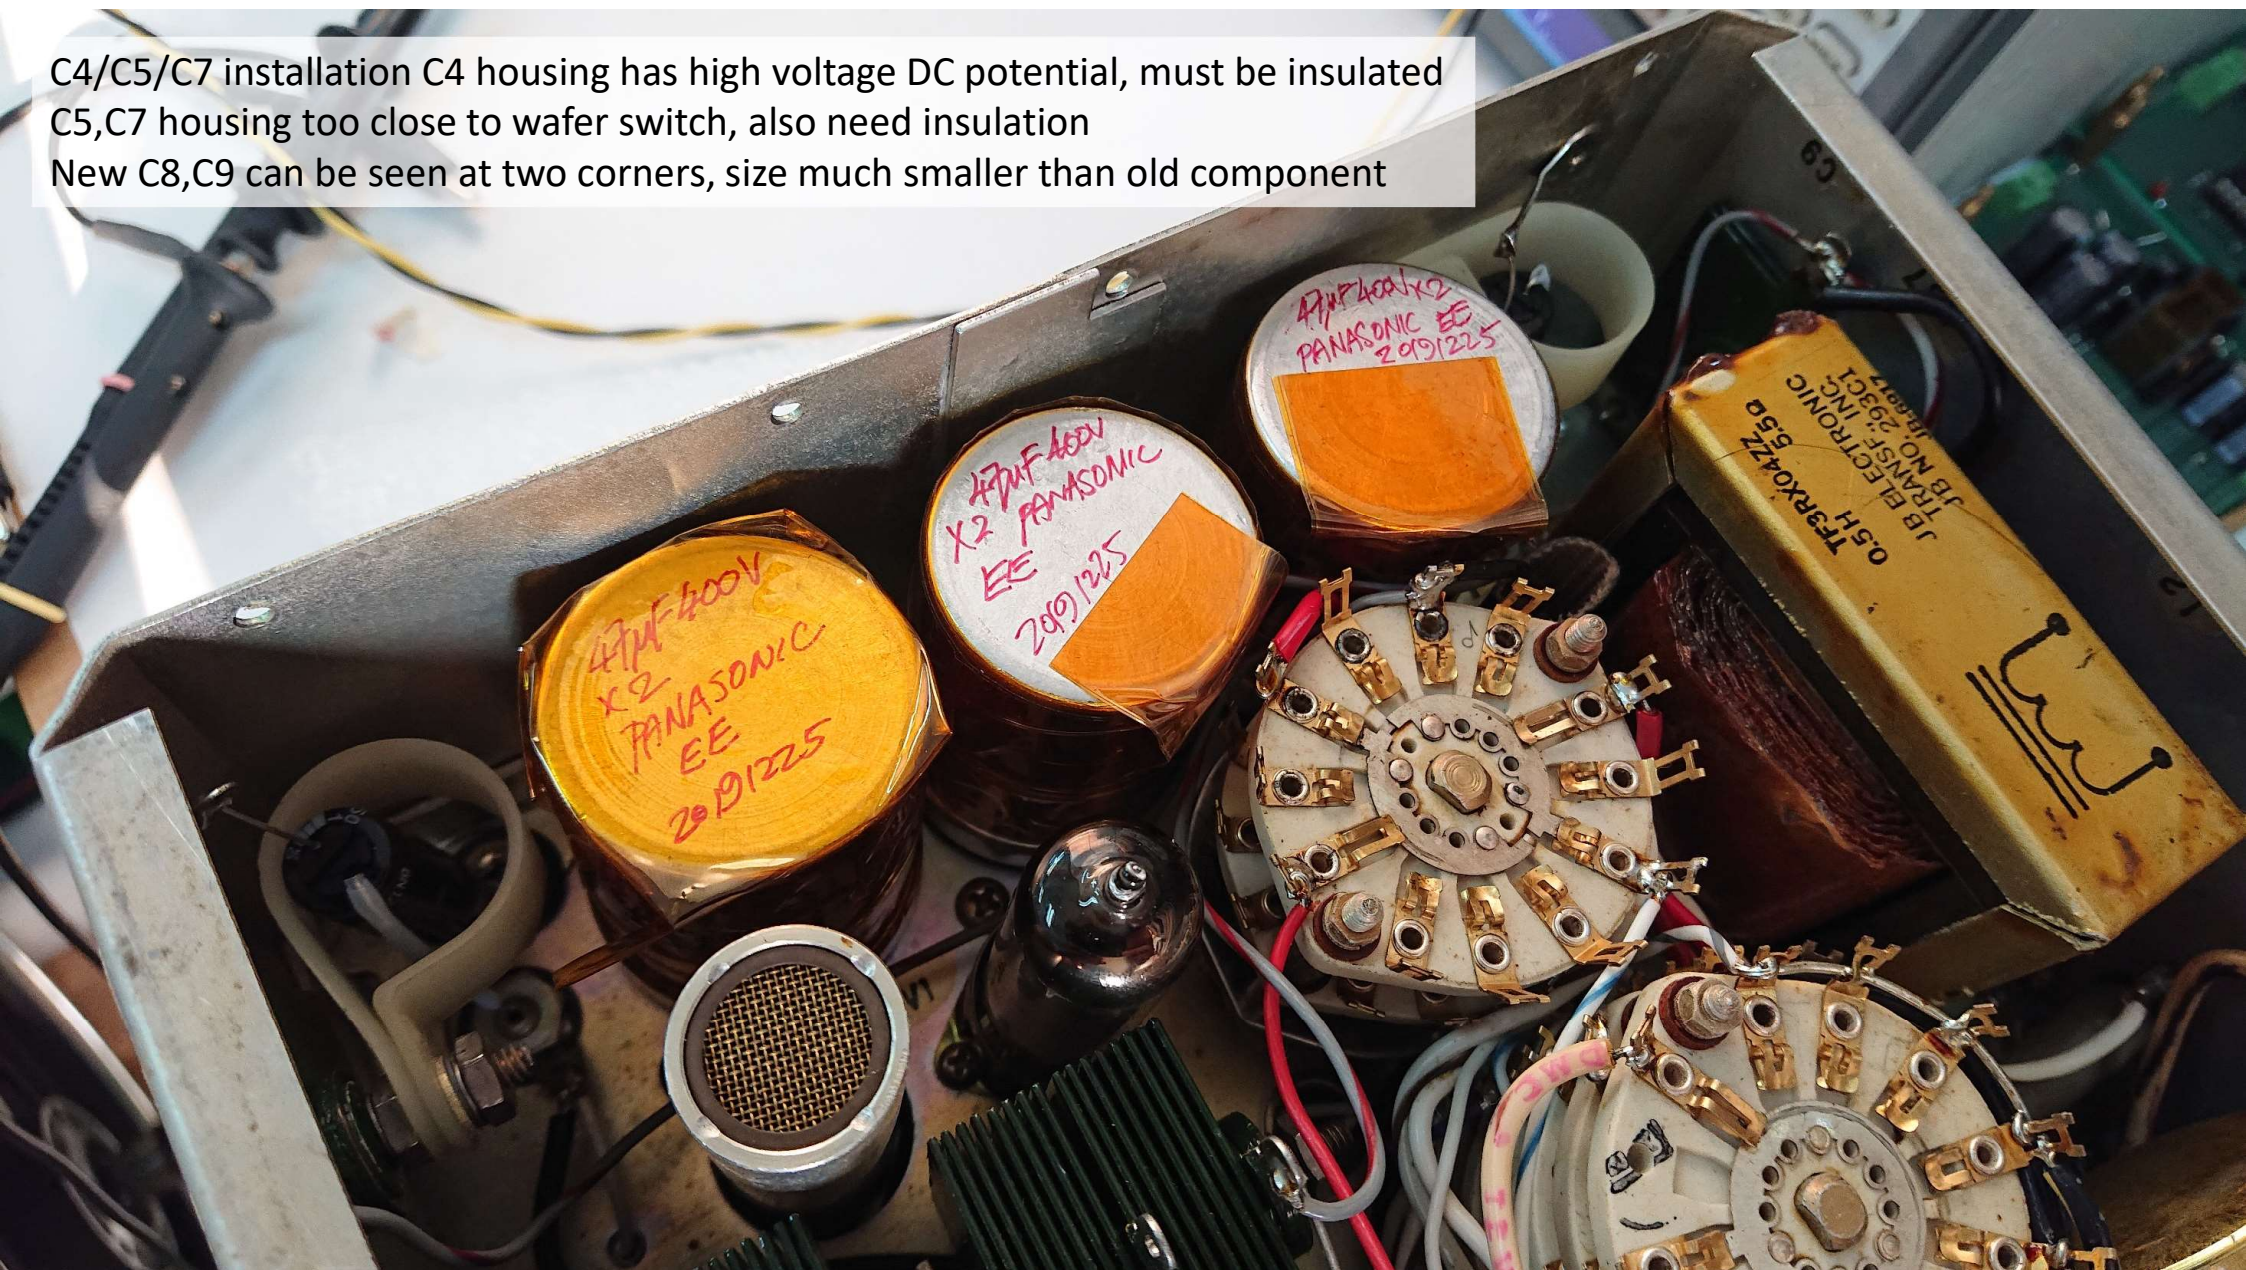
Battery negative return wiring has damaged insulation at center pole of fuse socket, caused by interference with chassis cutout. Cable solder joint was adjusted. Heat shrinkable tube was added on top of damaged section.

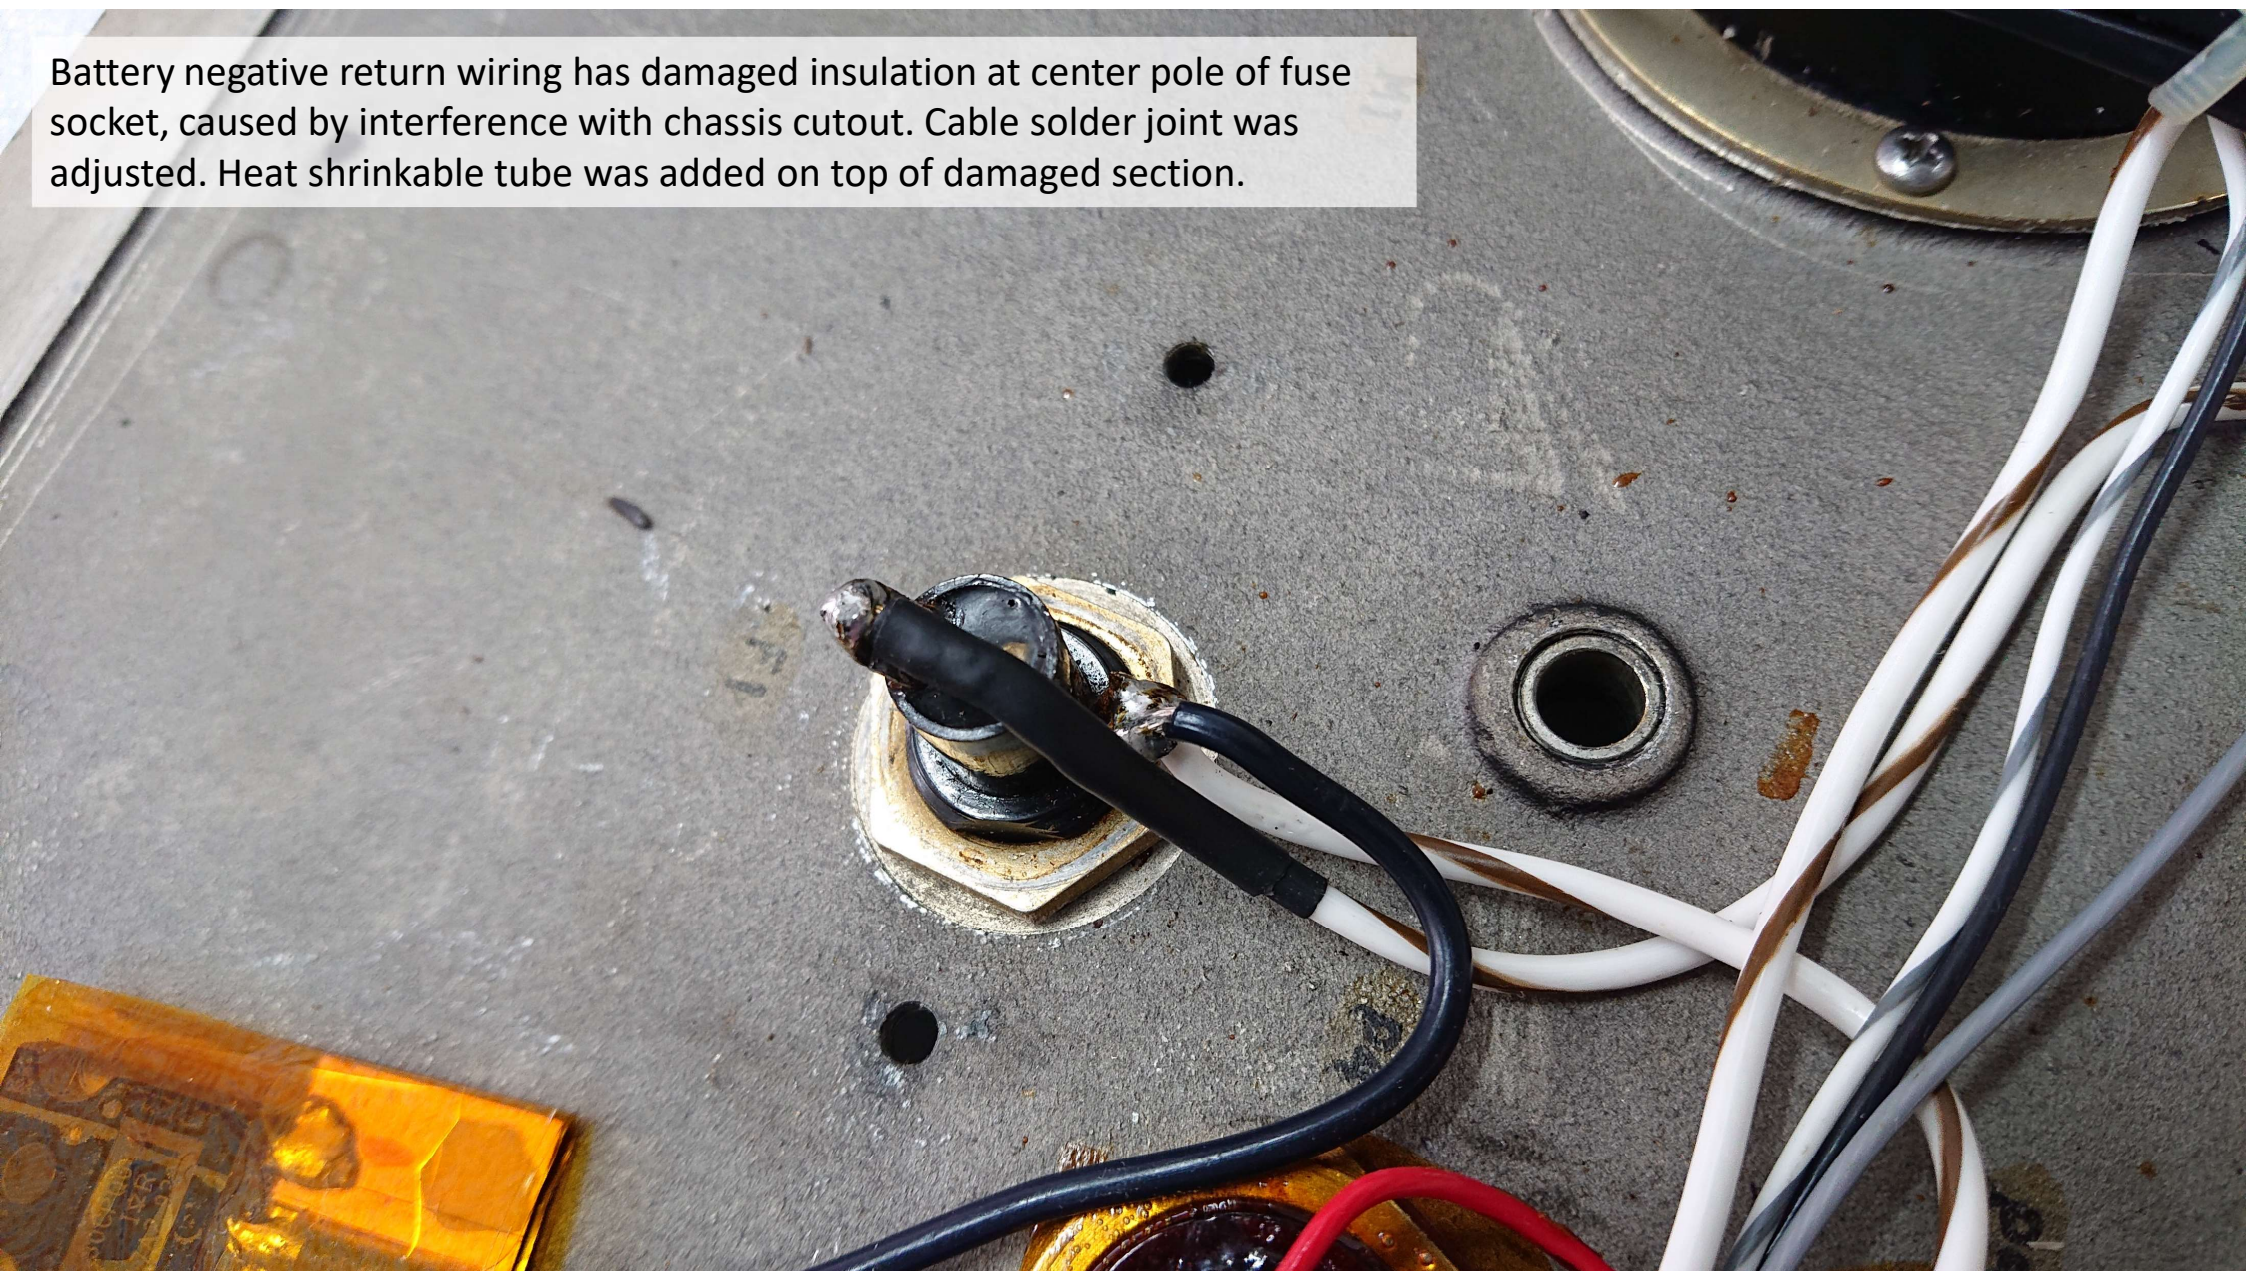
### High voltage Selenium rectifier characteristic

- Diode voltage drop 6V (130uA), 15.8V(100mA) total 16 stacks in series
- Single plate voltage drop 0.99V(100mA)
- Dynamic resistance 45.6Ω (20mA to 100mA)

### Replacing rectifier with common Silicon device such as 1N4007

- Requires series resistance, starts with original dynamic resistance (45Ω) as starting point of adjustment
- Apply 50% derating rule for this resistor (2x of 0.45W)
- Expect increase in output voltage at open-circuit

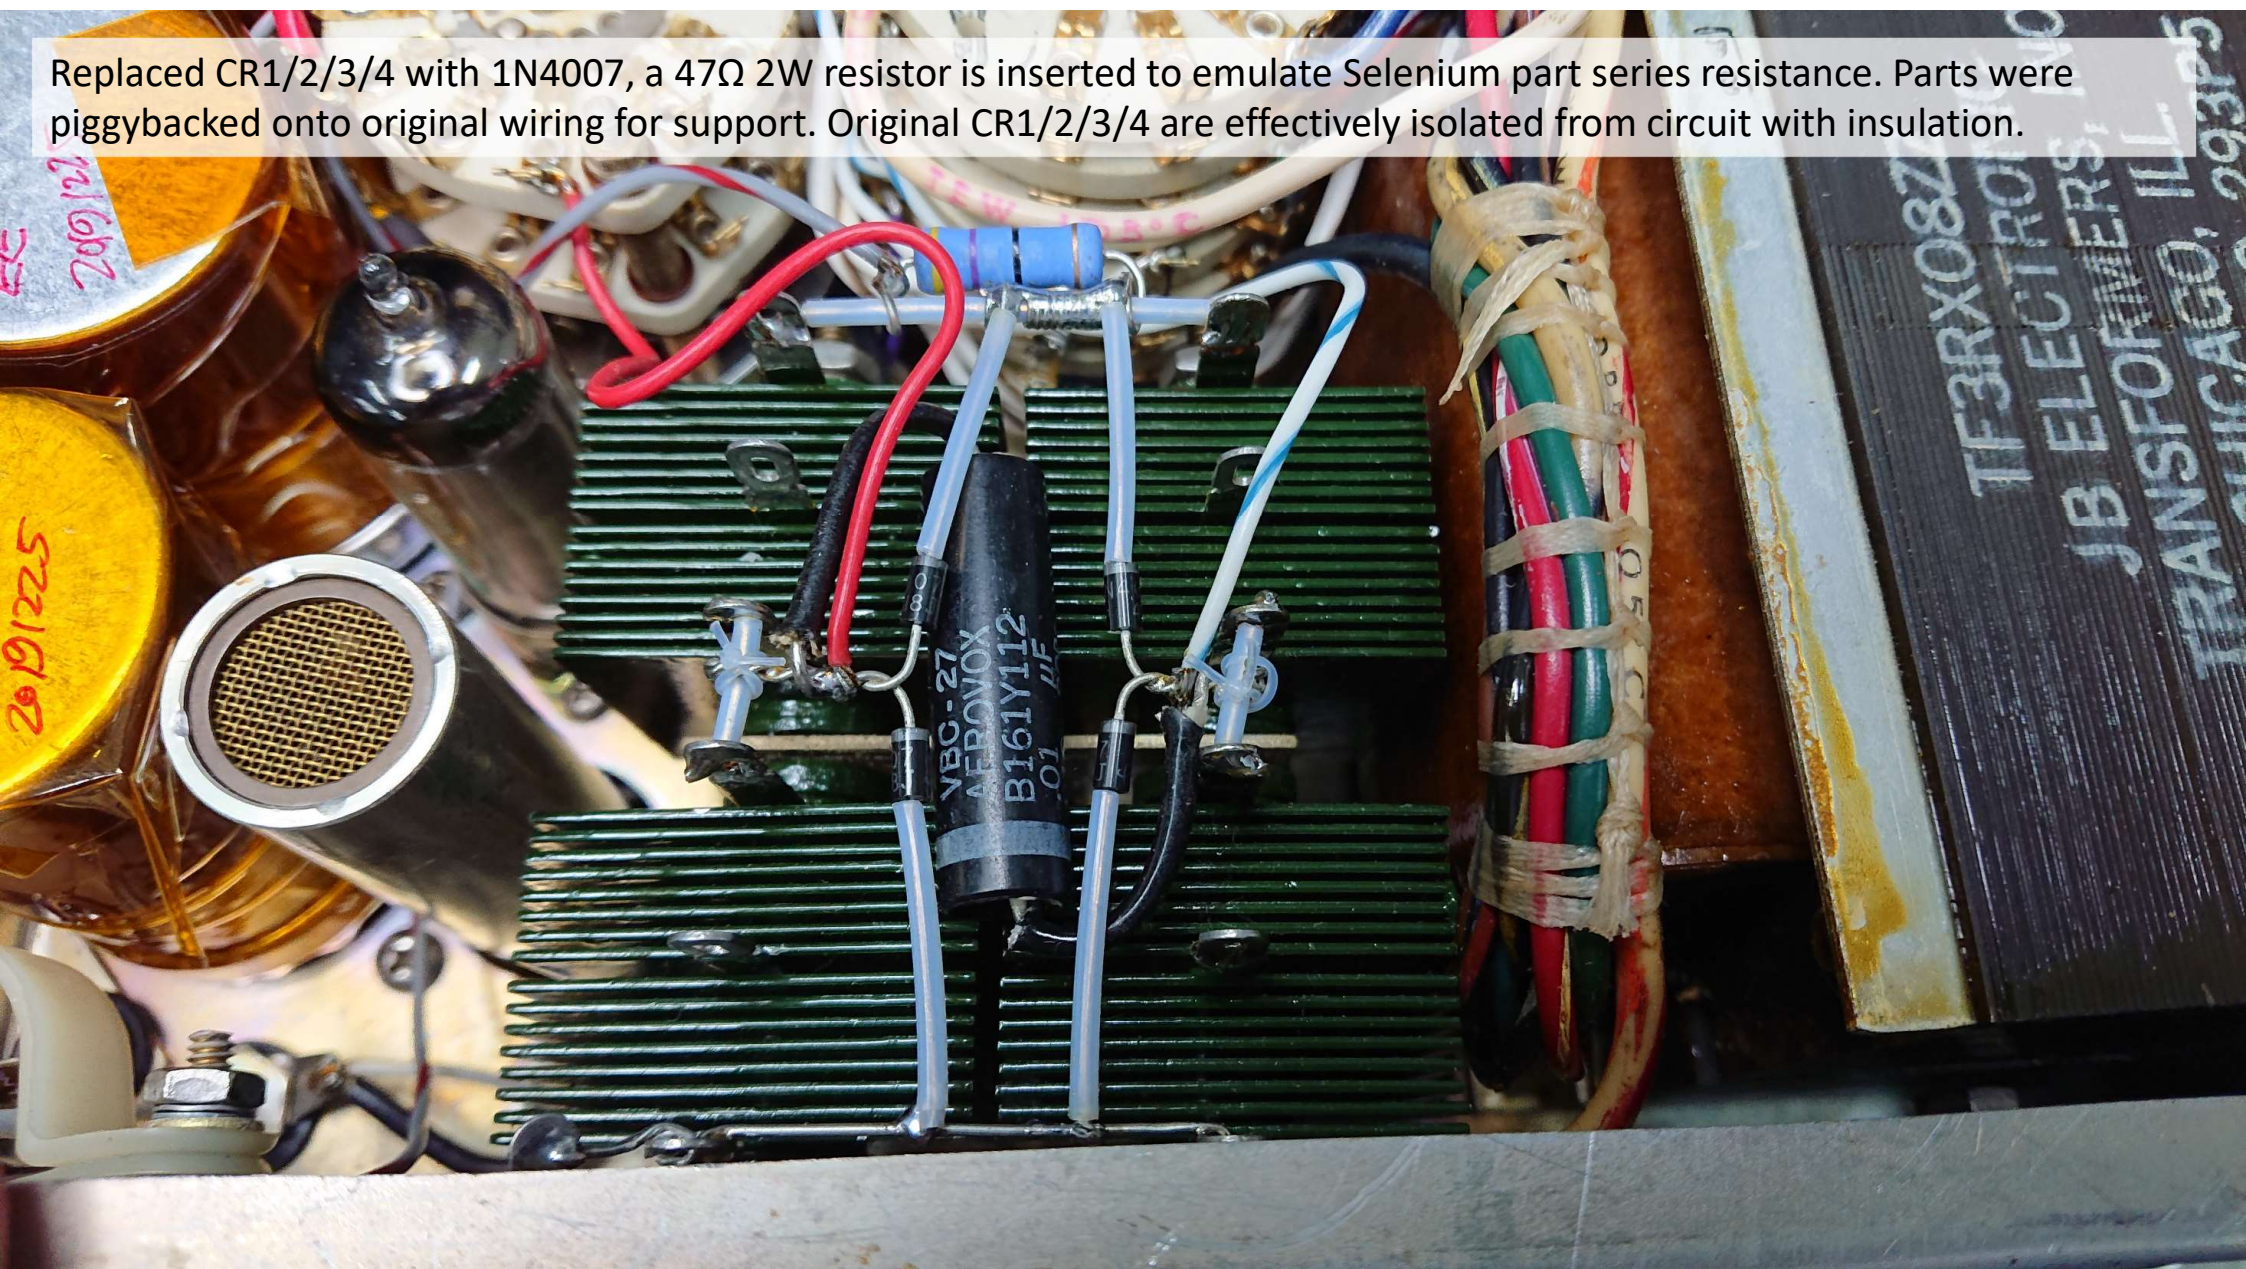
Waveform on one side of high voltage winding (100V/div) vs rectifier current (50mA/div)

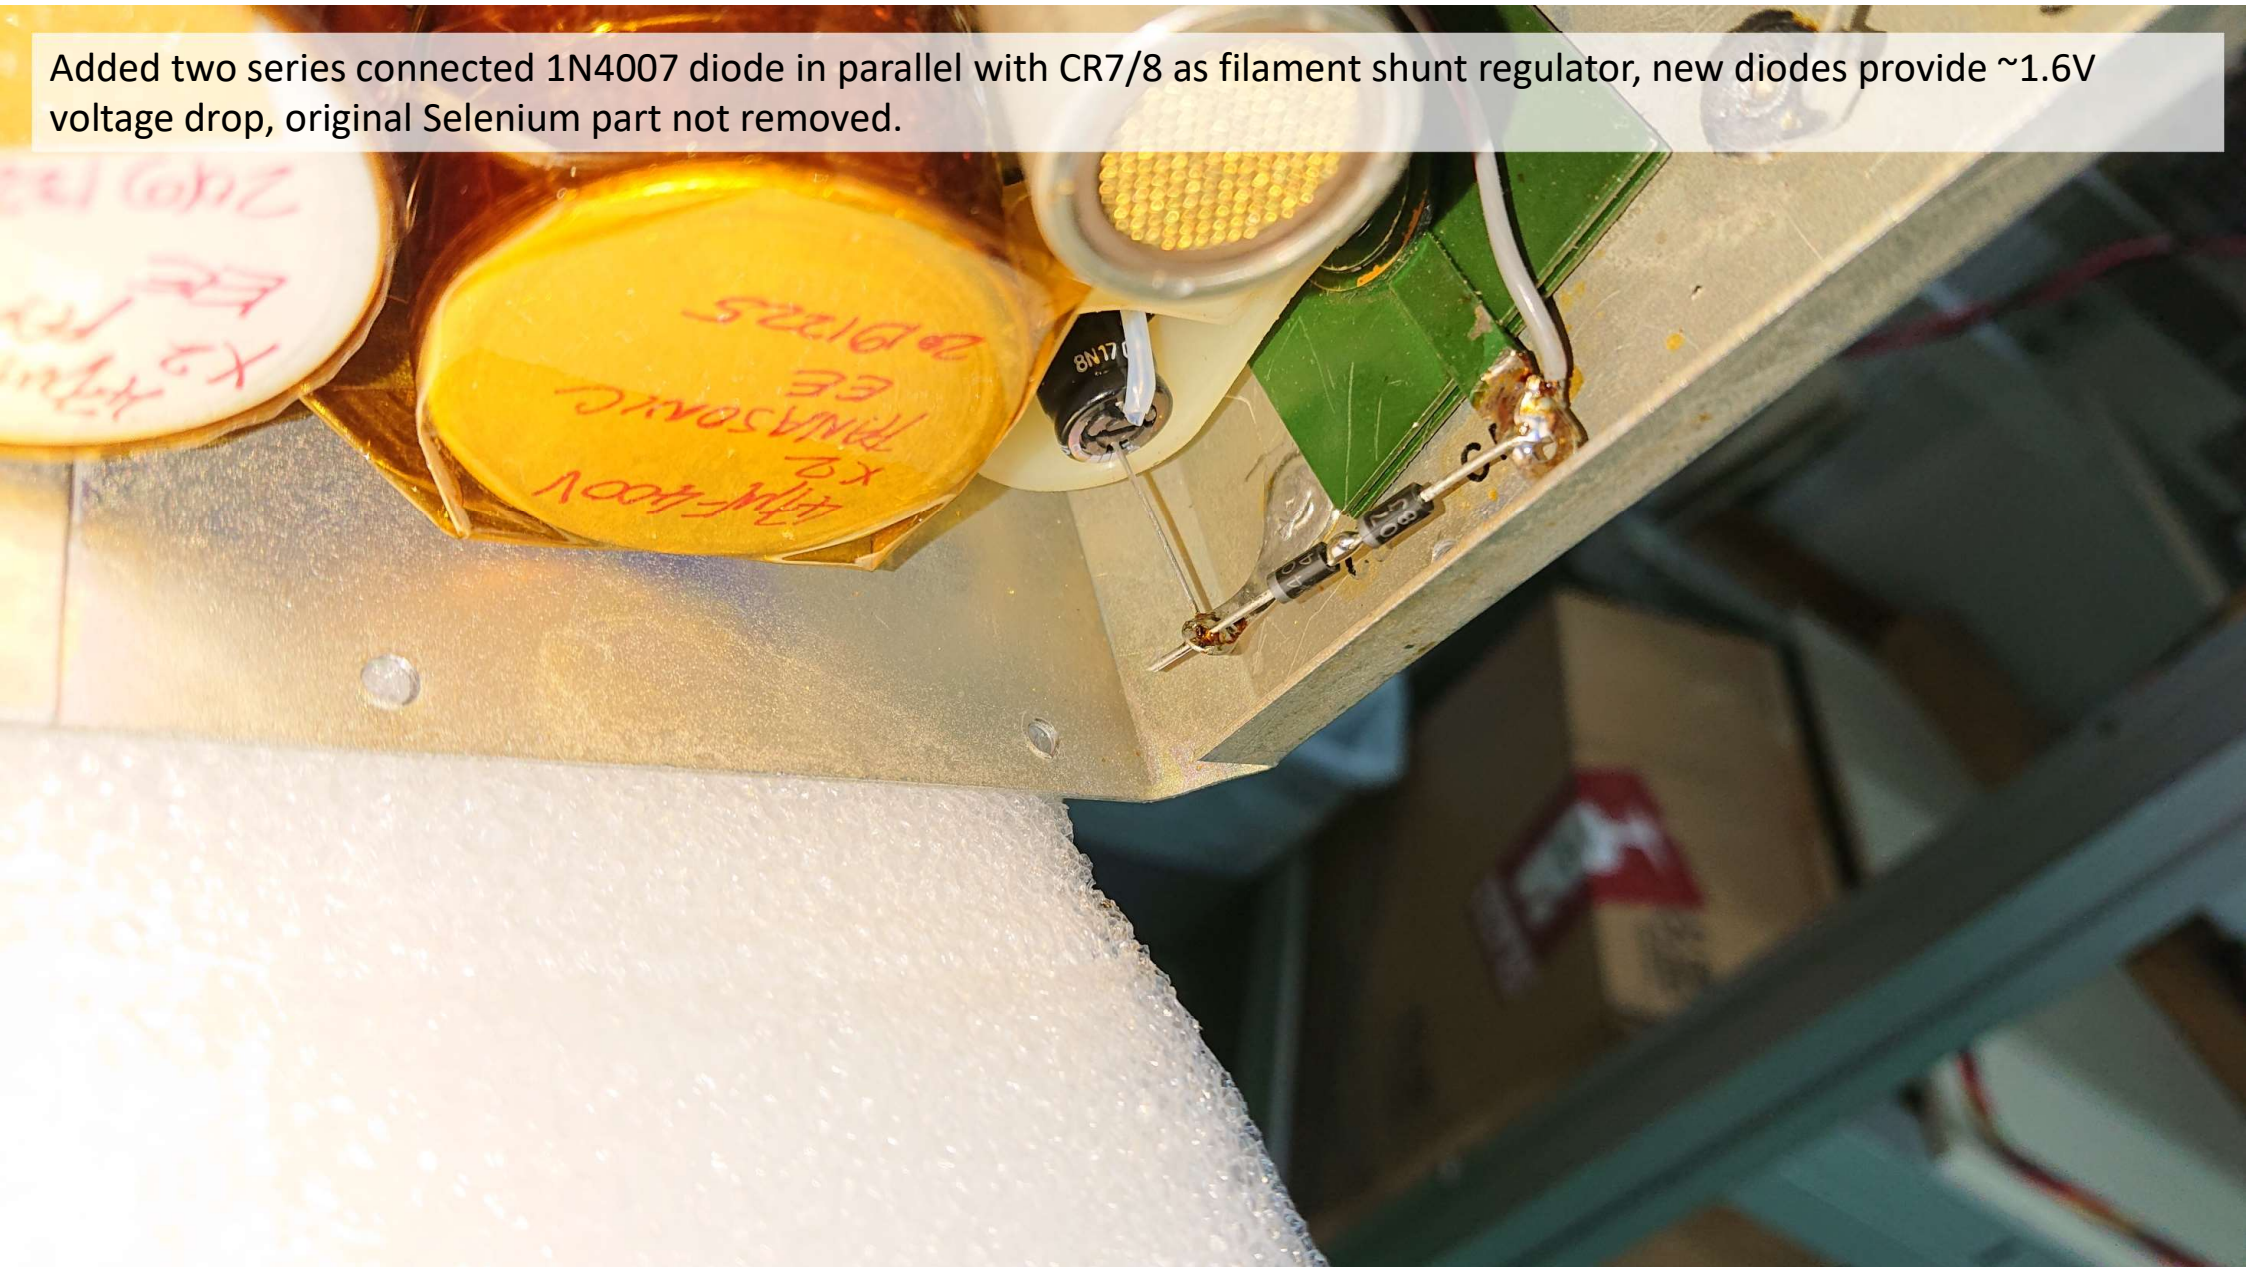
C3 was replaced with TDK EPCOS B32672L1103J000 10n 1600V PP capacitor
